Town	Hanson			
Addre:	SS High Street			
	ric Name <u>Hitchcock Parsonage</u>			
/ 				
Use:	Present Two-family			
Original Single family				
DESCRI	IPTION			
Date	1722			
Source	Town history			
Style	Early Georgian			
Architect Not known				
Exterior Wall Fabric Work shingle				
Outbuildings Barn (1790, 1850) Shed (1920's)				
Major	House increased in size c. 1780 Alterations (with dates) Kitchen Ell			
Porch	(early 1800's) (1920's) Stair Tower (1970's)			
Condit	ion Excellent, though the house			
has u	ndergone numerous alterations.			
Hoved	No Date No			
Acreage	e 1.38 acres

INVENTORY FORM CONTINUATION SHEET

Property Address 909 High Street

National Register of Historic Places Criteria Statement Form

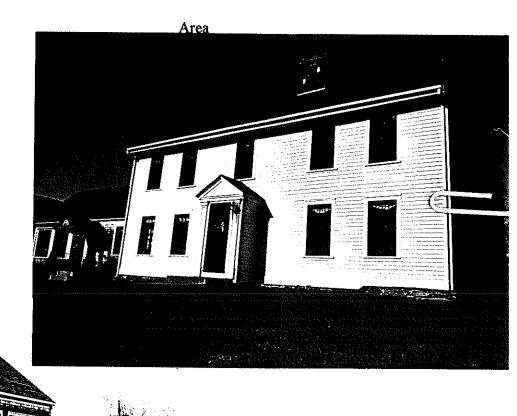
House increased in size Major Alterations (with dates) Kitch (earl Porch(1920's) Stair Tower (197

Condition Excellent, though the has undergone numerous alterat
